**ARIZONA DEPARTMENT OF ADMINISTRATION  
ASBESTOS INSPECTION / MANAGEMENT PLAN**

**RTC - AGRICULTURE LAB  
Building #: CG 1 015 - 0010  
2422 WEST HOLLY  
Phoenix, Arizona**

**Submitted By:  
Environmental Management Consultants, Inc.  
02/02/99**

**Subject:** Environmental Inspection  
Capitol Group Buildings  
RTC - AGRICULTURE LAB  
Building #: CG 1 015 - 0010  
2422 WEST HOLLY  
Phoenix, Arizona  
EMC Project # 3297

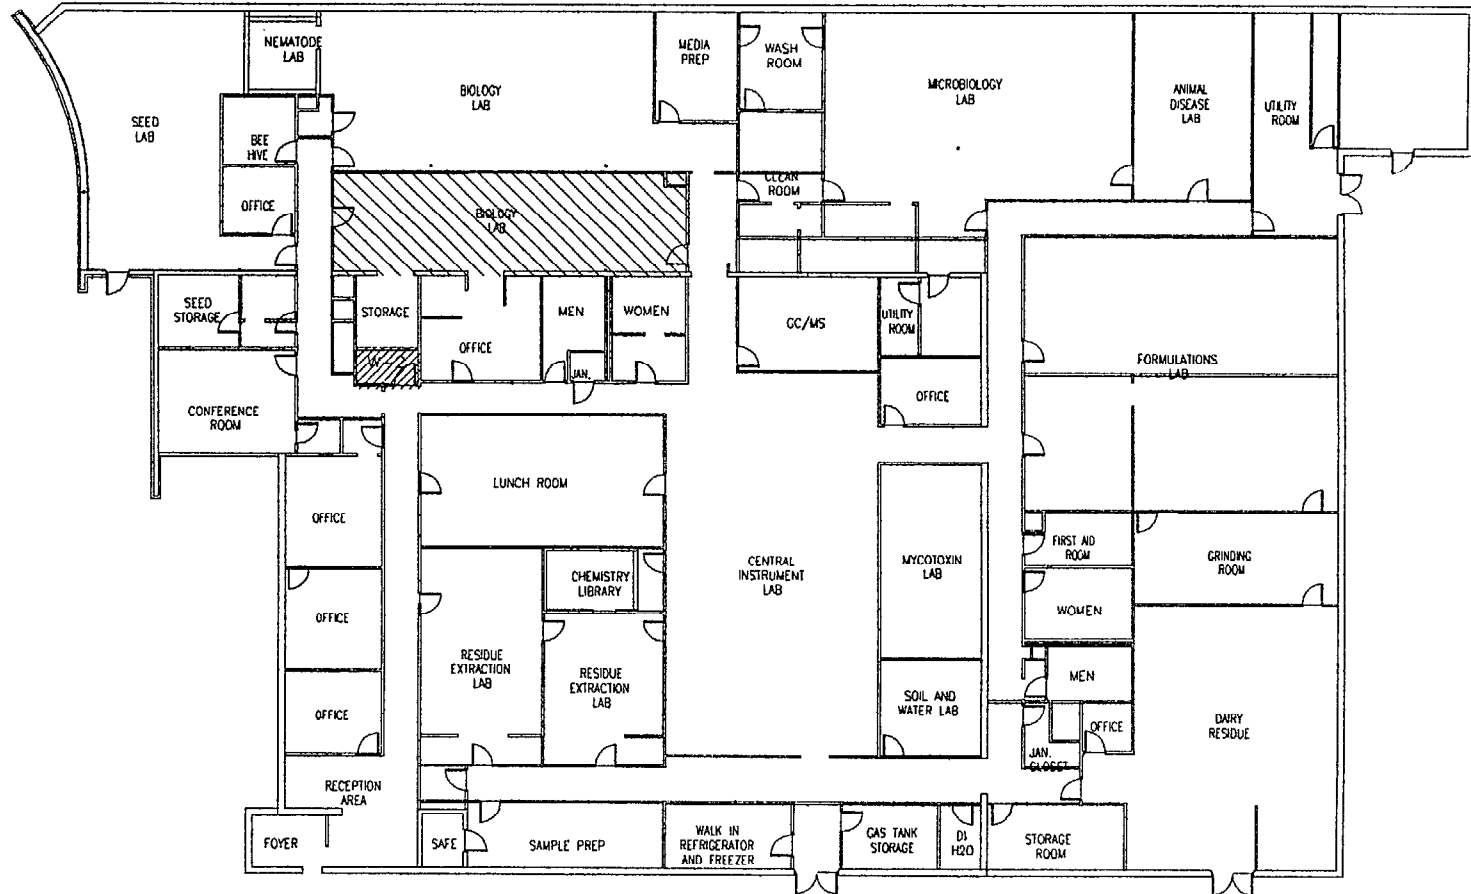
ACM LOCATION PLAN

- HA 05 :**        **MISC / NF        12x12 Beige Floor Tile (Mastic is Non-ACM) - approx. 45 sf.**  
Located in Women' s Room 2.
- HA 07 :**        **MISC / NF        9x9 White Floor Tile & Mastic - approx. 45 sf.**  
Located in Women' s Room 2, under 12x12 Beige Floor Tile.

- HA 08 :**        **MISC / NF        Residual Black Floor Mastic - approx. 900 sf.**  
Located in Bio Lab 2 under rubber membrane flooring material. Assumed under 12x12 Floor Tile in this room and under all areas / rooms where rubber membrane floor exists. Areas with rubber membrane flooring should be verified prior to renovations / removal.

- HA : 05 12x12 Beige Floor Tile  
HA : 07 9x9 Floor Tile & Mastic  
(Under 12x12 Floor Tile)  
HA : 08 Residual Black Floor Mastic

If renovation or demolition will affect the asbestos containing material(s) found in this report, removal is recommended prior to these actions. The asbestos abatement should be performed by a licensed, insured asbestos abatement contractor.

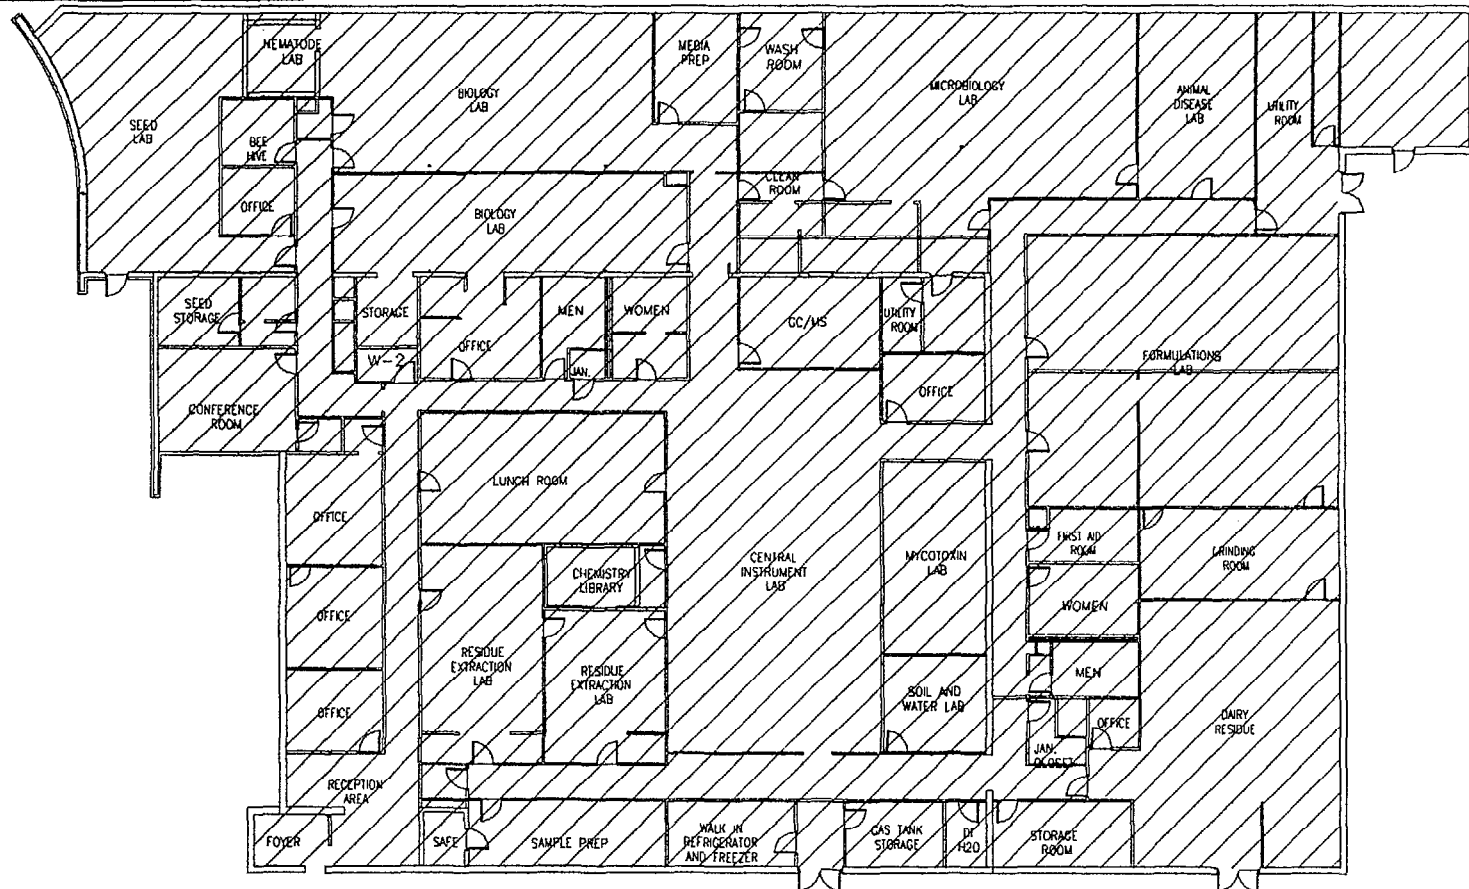
ACM LOCATION PLAN

- HA 12 :**        **MISC / NF        Transite Panels - approx. 1,000 sf.**  
Tested in Dairy residue, Formulations, and Central Instrument Laboratory. Observed throughout the facility in Laboratory hoods.

HA : 12 Transite Panels

NOTE: Material is in Laboratory hoods.

Transite Panels - approx. 1,000 sf. (OSHA Class 2)

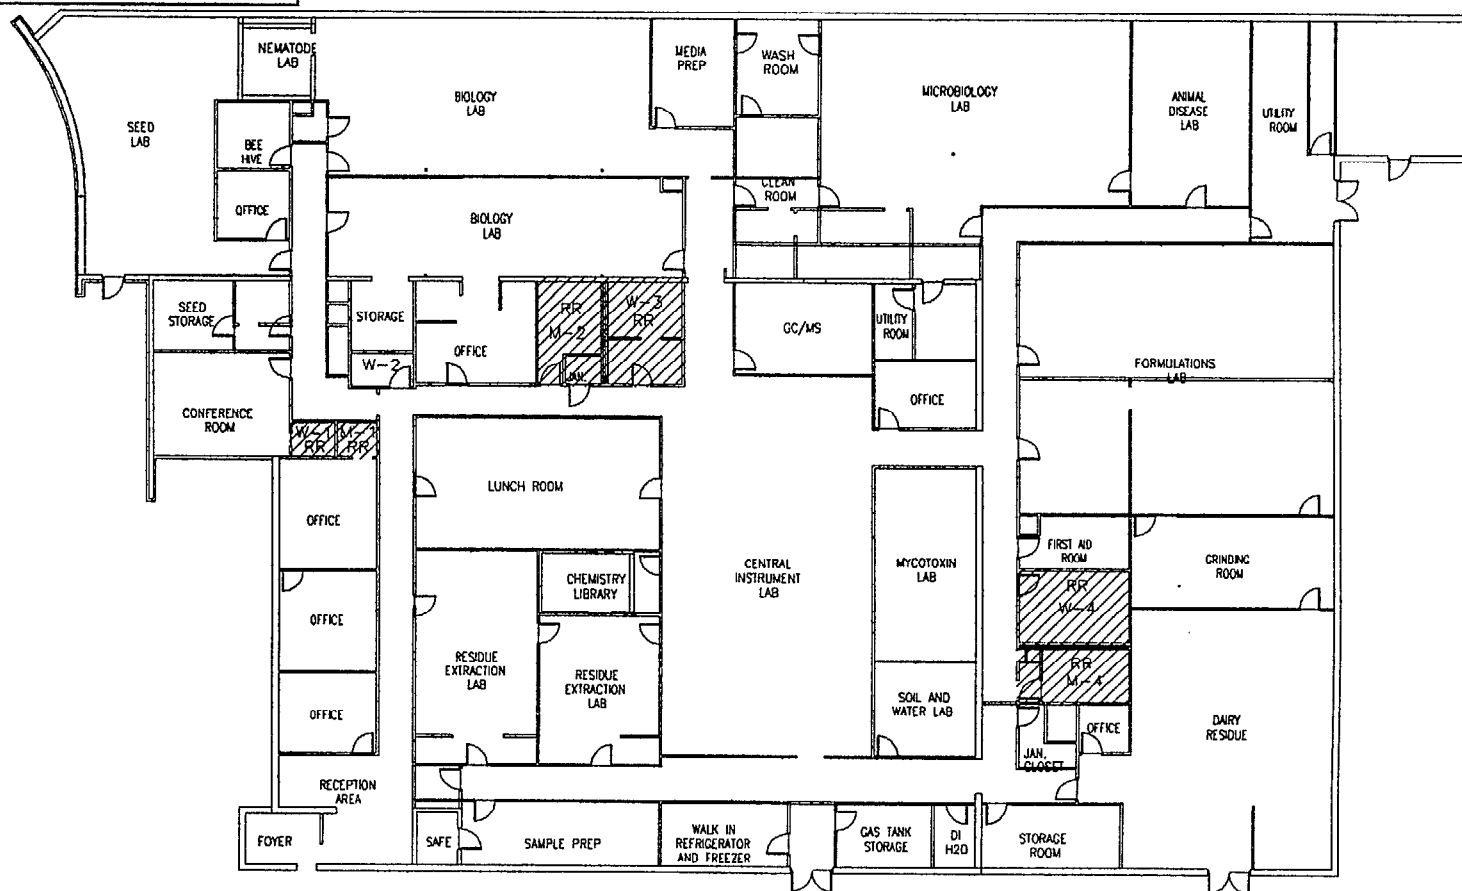
ACM LOCATION PLAN

- HA 13 :**        **MISC / NF        Mirror Mastic - Unquantified.        (Assumed To Be ACM)**  
Mastic adhering mirrors to wall surfaces in all Restrooms. Observed, but inaccessible, in Women's Room #4. This material will be Assumed to be ACM until access by destructive means are used enabling material testing.

HA : 13 Mirror Mastic (Behind glass)

NOTE: This material is ASSUMED ACM until tested Non-ACM. Material is inaccessible at this time.

***Mirror Mastic - Unquantified. (OSHA Class 2 - S. P.)  
Assumed to be ACM - Inaccessible without destructive means.***

On the materials listed below, material testing was not possible during inspection - inaccessible. These material(s) will be assumed to be asbestos containing until material testing by destructive means are completed.
